Inspection Report

Minerals Regulatory Program

Mine Name: ML 27618	Permit Number: S/025/0025
Operator Name: Althea Crapo & Russ Henry	Inspection Date: June 6, 2012
Inspector(s): Peter Brinton	Time: 1:45pm – 2:15pm; 3:00pm – 3:30pm
Other Participants: Russ Henry	Mine Status: Active

Purpose of Inspection: Evaluate Trail Canyon slope stability and current mining in the east area

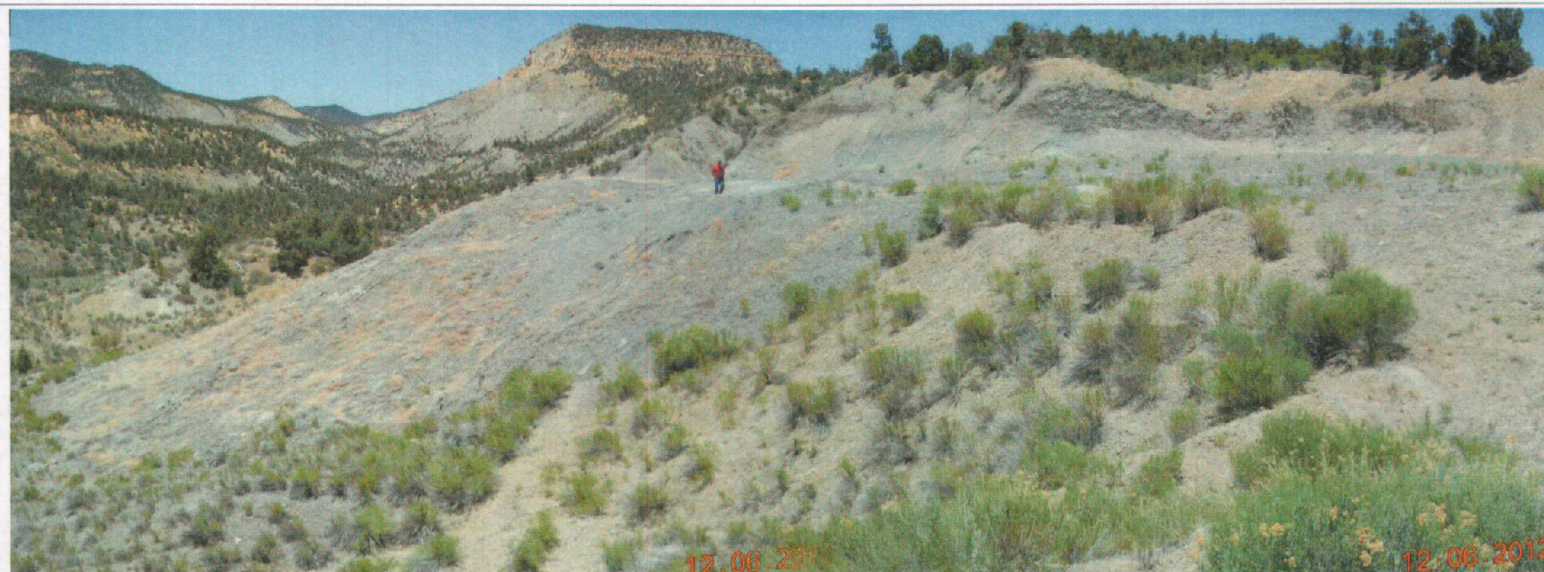
The slope in Trail Canyon area of the permit remained unstable as evidenced by tension cracks above the slope. The operator had done some grading work at the crest of the slope. Additional slumping had occurred since the last inspection, though on a smaller scale, and future slumping was expected, in part because the grading had added load to the lower slope. Photos were taken to document site conditions.

Trail Canyon: Stitched photo showing the unstable, unvegetated slope, looking north. A small amount of the regrading work is where Russ Henry stands.

The slope in Trail Canyon remained unstable. Nearby revegetated slopes of similar steepness with successful revegetation appeared to be more stabilized. It is expected that growth on the unstable slope from seeding by the operator and/or natural processes will likewise be successful with time, despite the observed instability.

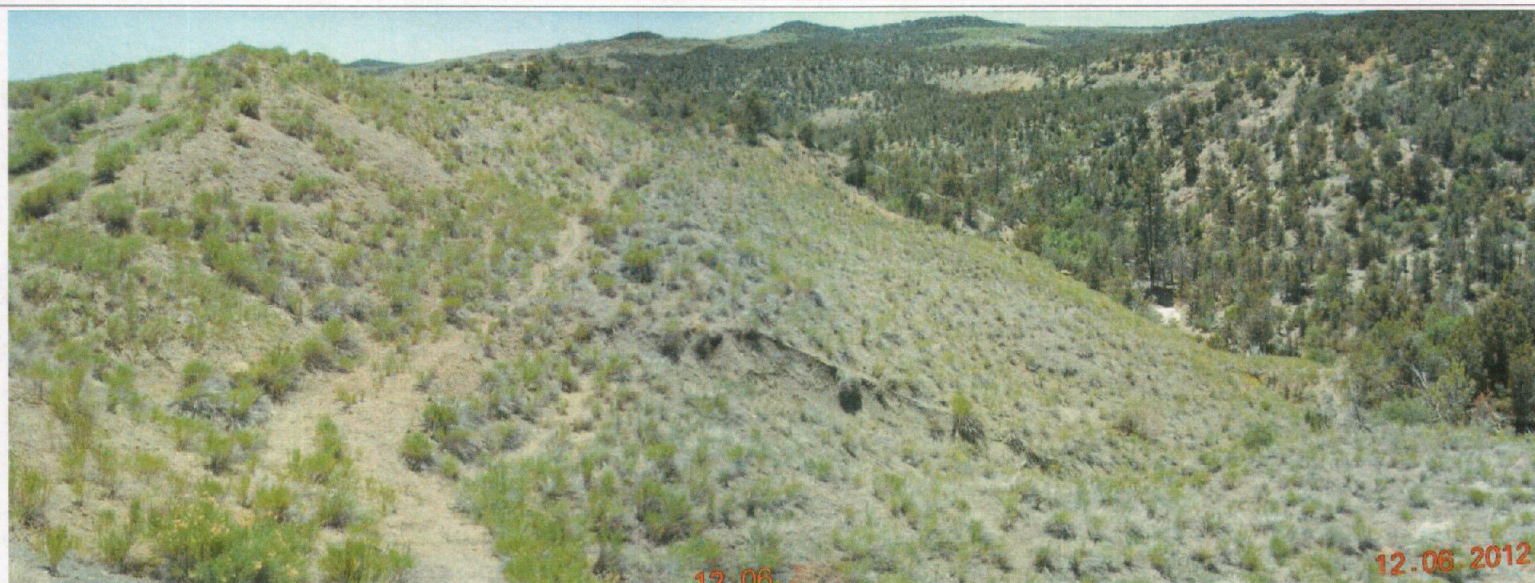
Other nearby mines were observed to have steeply-sloped dumps with slumping, and on which beneficial vegetation (most commonly rabbitbrush) was growing well.

Trail Canyon: Stitched photo of slopes with beneficial vegetation located just south of the unstable, bare slope. Some minor erosion visible.

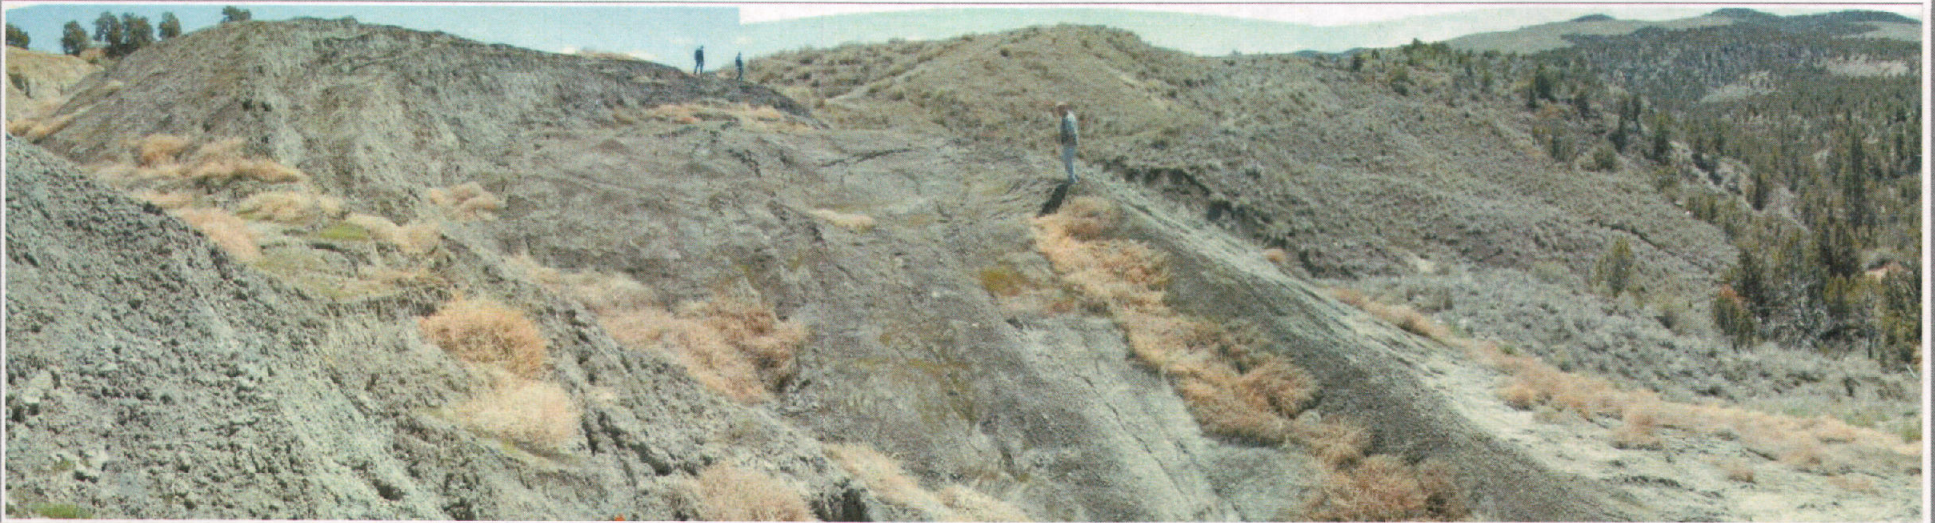
Trail Canyon: **April 2011** stitched photo showing the slumping slope following a very wet season.

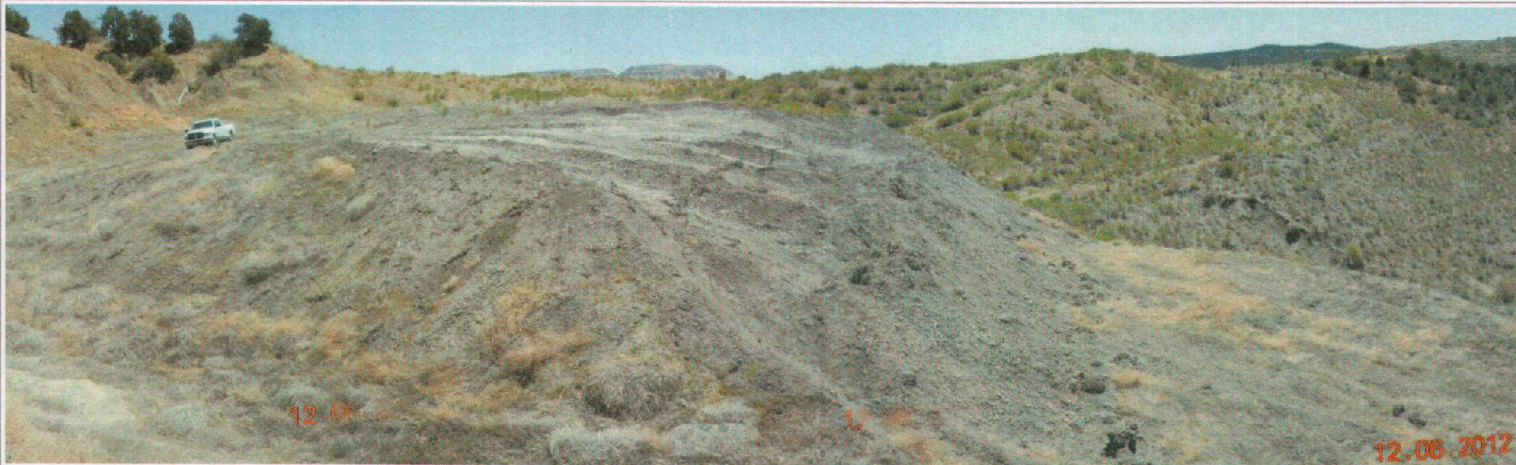
Trail Canyon: **June 2012** stitched photo showing the partially regraded slope after a dry winter and spring season. Some post-work cracking at the crest is visible at the center.

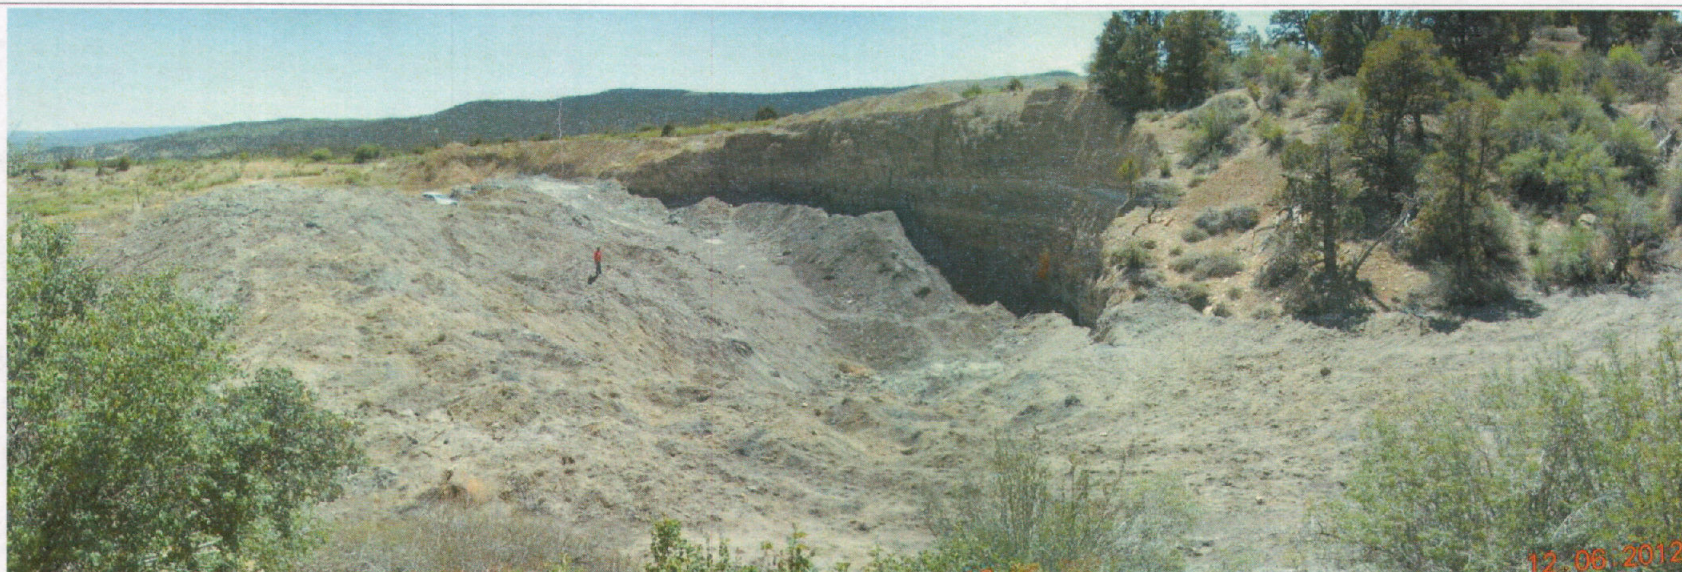
Mining had been actively occurring on the east area since the last inspection, and dumps and pits had expanded. Ponded water had been present behind dumps blocking a dry drainage at the north end of the disturbance in 2011, but there was no ponding behind dumps in the drainage in 2012. Water was also present in the pits in 2012, though much less than the amount observed in 2011. Photos were taken to document site conditions.

East Side (ML51615): Stitched photo looking generally south and off highway into pit. See Russ standing in the pit for scale. Overburden storage (gray) has filled the drainage to the right.

It was estimated that additional reclamation bond was needed for the ML 51615 area, since the disturbance was likely over 2 acres (based on 2011 aerial photos).

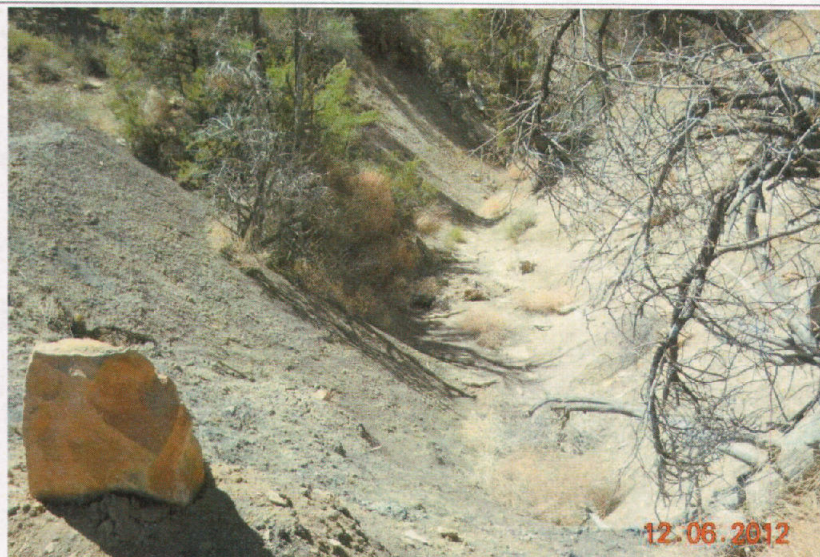
East Side (ML51615): Backfilled drainage with gray overburden on the left.

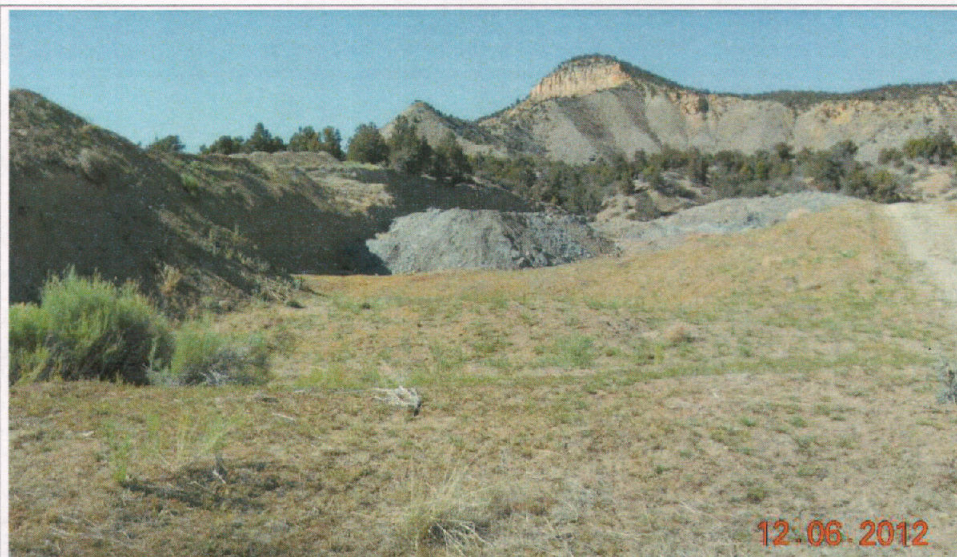
East side: Looking north toward pit from access road at recontoured, growing backfill (foreground).
